Weld Inspection Report

Customer	A1 Group	Report Number	10312023_001
Project	Vehicle storage racks visual inspection	Job Number	Not available
Location	Silver Birches, Highland Avenue. Wokingham RG41 4SP	Inspection Date	31/10/2023
Material	Carbon Steel, Groups 1 and 2	Weld Process	MAGS 135 and MMA 111
Plate/Pipe	SHS/RHS	Surface Condition	Left as laid
Dimensions	N/A	Weld Preparation	Not witnessed
Heat Treatment	N/A	Drawing Number	See items tested
Temperature	Ambient	Identification	As indicated on rack
Joint Details	Tee fillet/part penetration butt welds	Acceptance Standard	BS EN 5817 level D

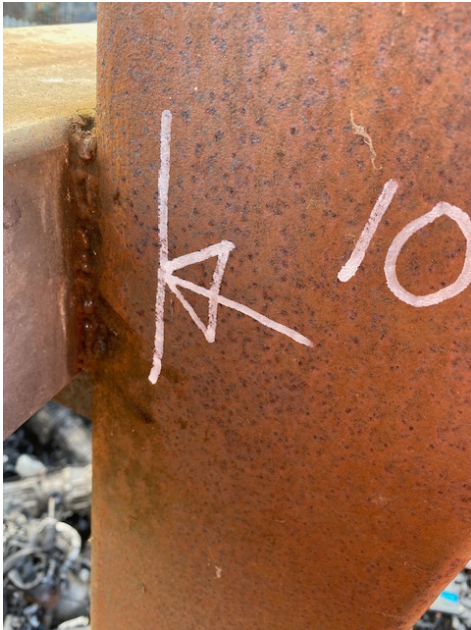
R10, Weld bead not acceptable

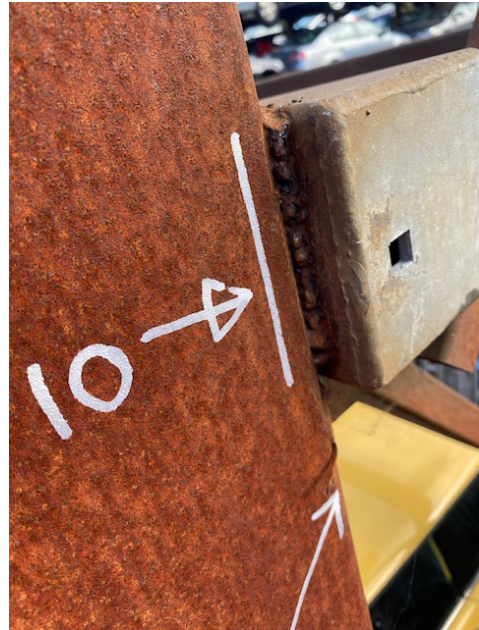
R10, Weld bead not acceptable

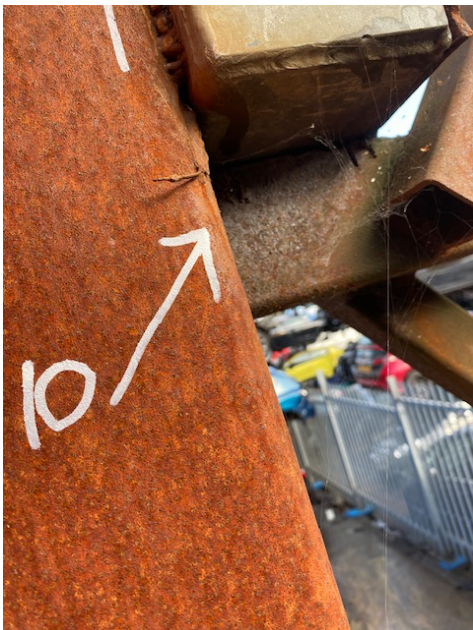
R10, Weld bead not acceptable

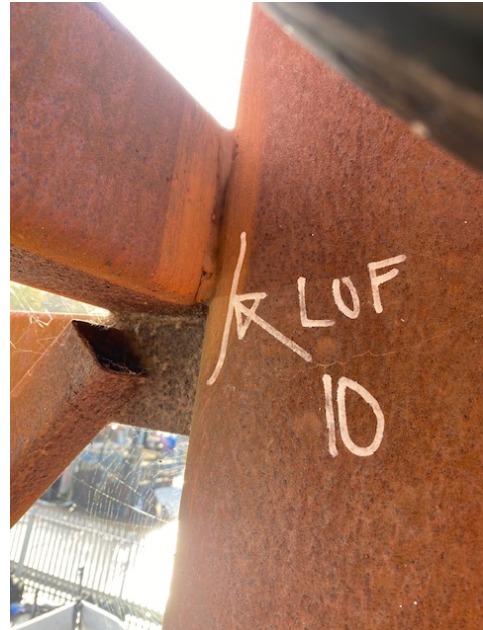
R10, Lack of side wall fusion

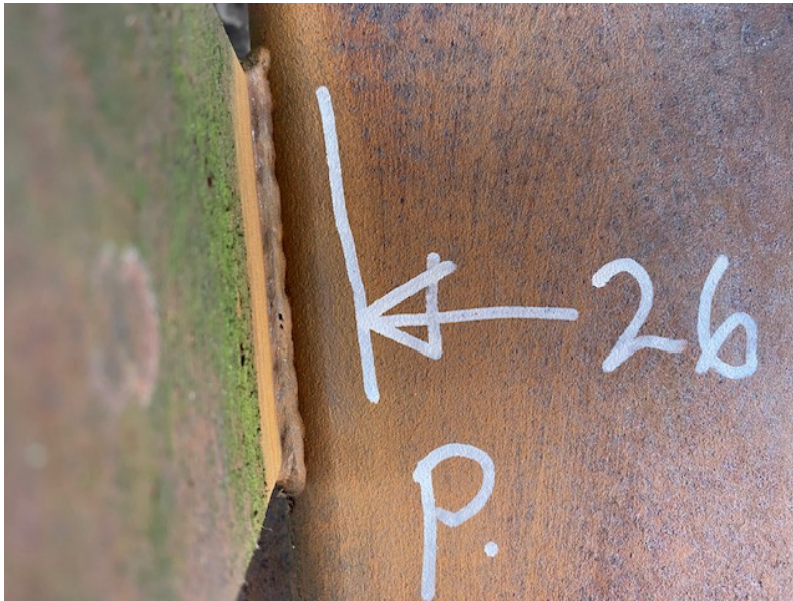
R26, Cluster porosity

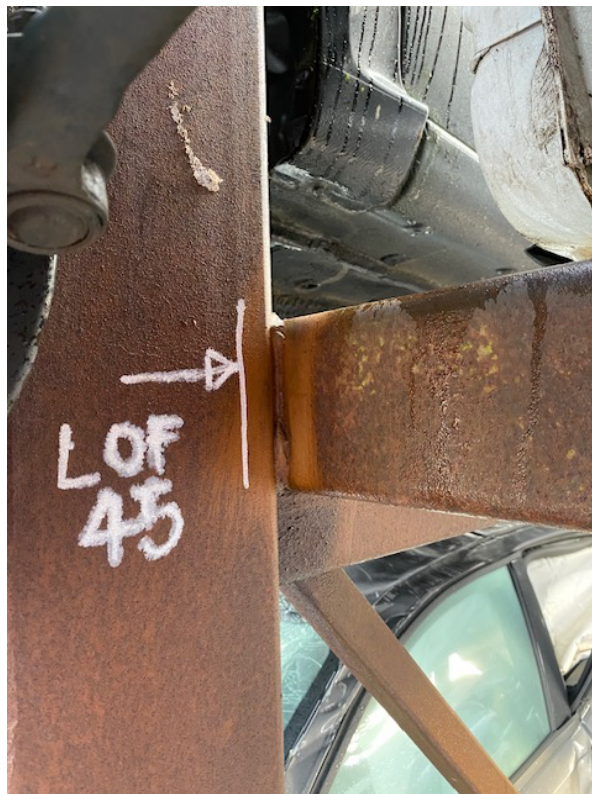
R45, Lack of sidewall fusion

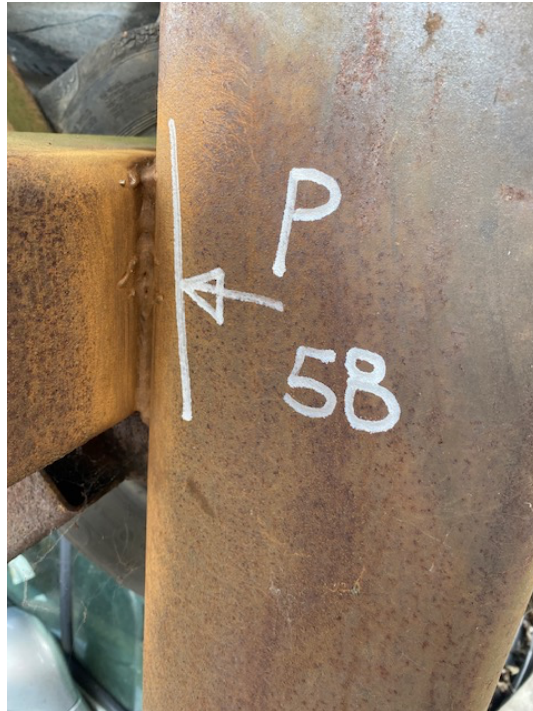
R58, Cluster porosity

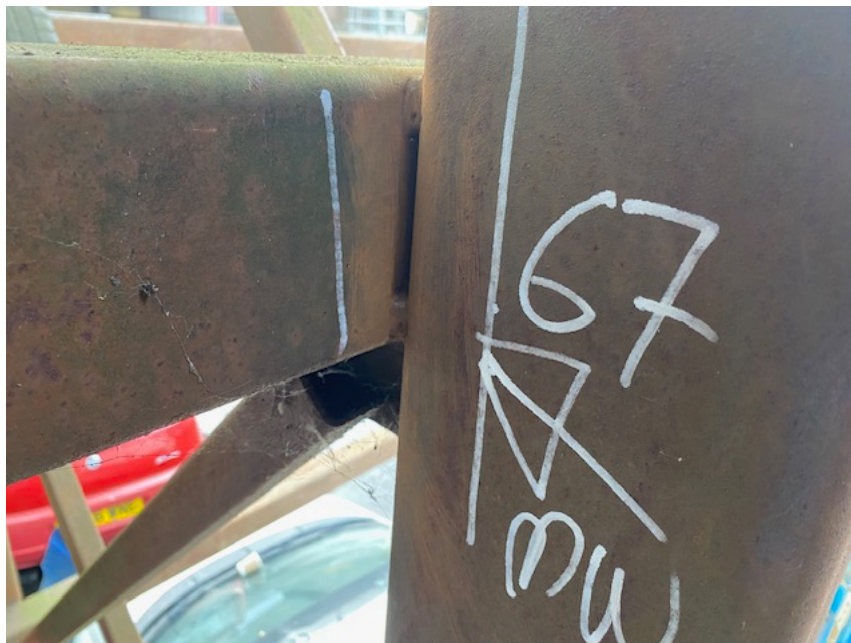
R67, Missing weld

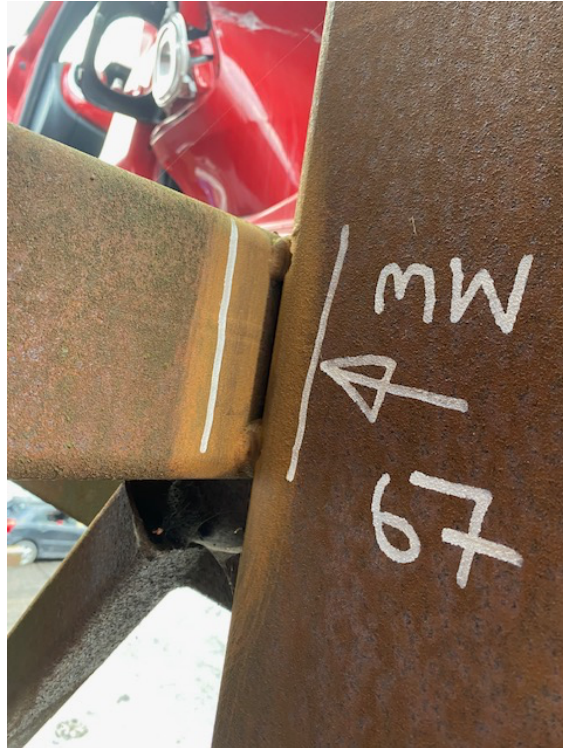
R67, Missing weld
