Weld Inspection Report

Customer	A1 Group	Report Number	11212023_001
Project	Vehicle storage racks visual inspection	Job Number	Not available
Location	Silver Birches, Highland Avenue. Wokingham RG41 4SP	Inspection Date	20-21/10/2023
Material	Carbon Steel, Groups 1 and 2	Weld Process	MAGS 135 and MMA 111
Plate/Pipe	SHS/RHS	Surface Condition	Left as laid
Dimensions	N/A	Weld Preparation	Not witnessed
Heat Treatment	N/A	Drawing Number	See items tested
Temperature	Ambient	Identification	As indicated on rack
Joint Details	Tee fillet/part penetration butt welds	Acceptance Standard	BS EN 5817 level D

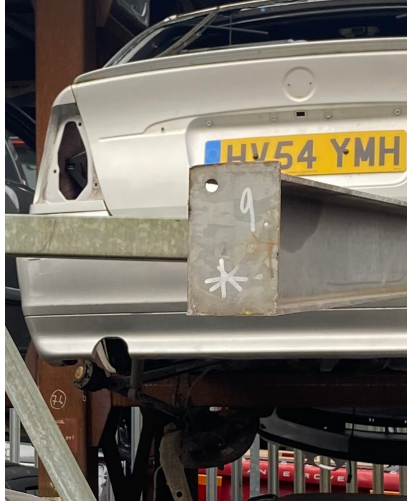
10 No galvanised storage racks inspected (Van/Ebay area) and **fractured welds** noted, no individual identification numbers present. Identification as shown below.

Van/Ebay area, defective racking identification *9 (ie rack number 9 of 10 rejected).

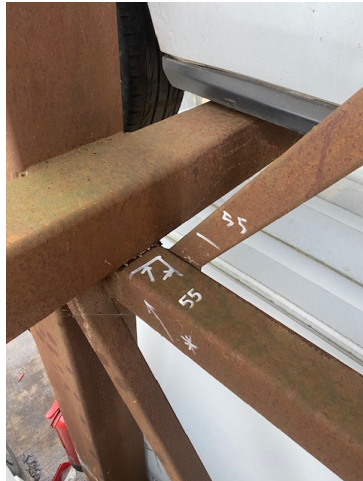
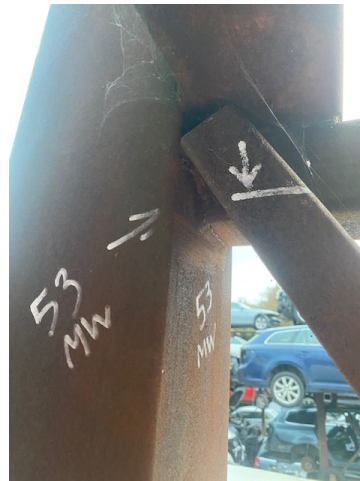
- 12, 25, 52, 53, 54, 55, [6 racks not acceptable]

Typical marking/identification of missing welds, ie racks 55 and 53.
