Weld Inspection Report

Customer	A1 Group	Report Number	10302023_001
Project	Vehicle storage racks visual inspection	Job Number	Not available
Location	Silver Birches, Highland Avenue. Wokingham RG41 4SP	Inspection Date	30/10/2023
Material	Carbon Steel, Groups 1 and 2	Weld Process	MAGS 135 and MMA 111
Plate/Pipe	SHS/RHS	Surface Condition	Left as laid
Dimensions	N/A	Weld Preparation	Not witnessed
Heat Treatment	N/A	Drawing Number	See items tested
Temperature	Ambient	Identification	As indicated on rack
Joint Details	Tee fillet/part penetration butt welds	Acceptance Standard	BS EN 5817 level D

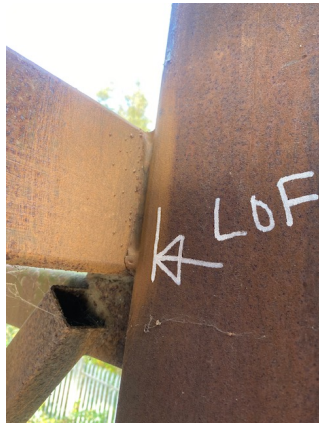
Rack 82, evidence of porosity and lack of side wall fusion.

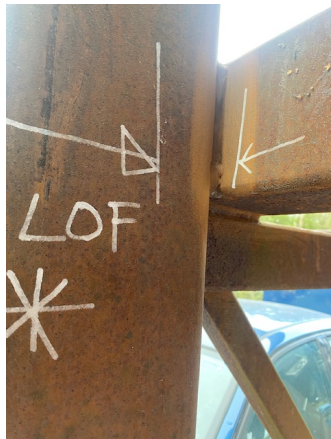
Rack 85, evidence showing lack of side wall fusion.
